Experience of operating lines at speeds above 160 km/h

Krzysztof Waszkiewicz

Member of the Management Board responsible for railway maintenance

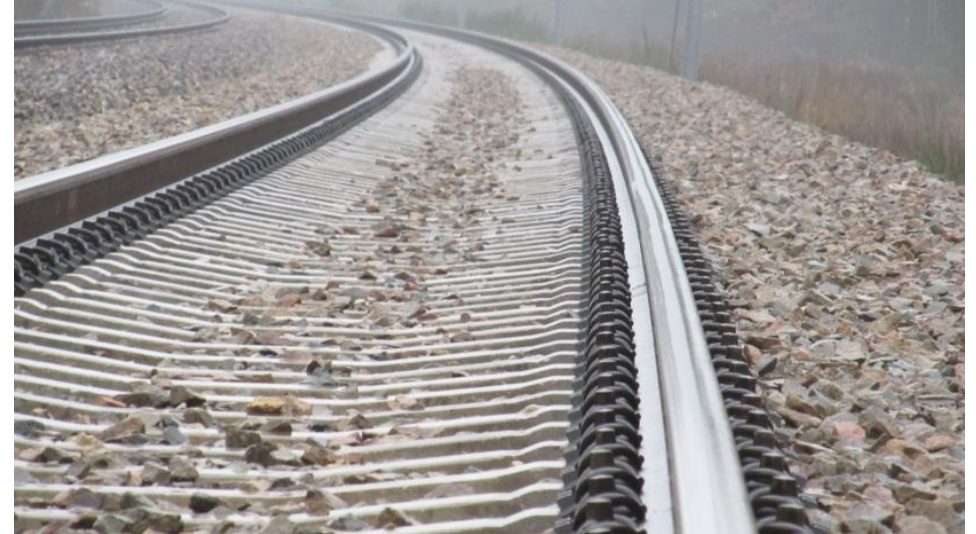
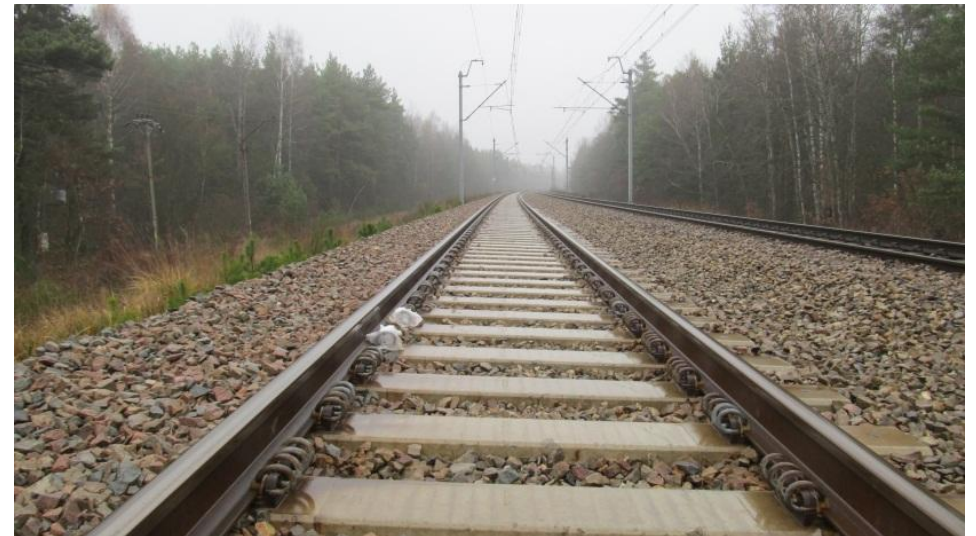
Flying ballast in winter conditions (uplift of ballast stones by falling ice blocks from the train)

- Amendments to the DSU for the assessment of damage to SYOPE panels,
- use of measures to prevent snow and ice build-up on the ED250 chassis,
- limitation of the travelling speed in case of ice on the train.

- changes to the regulations (profiled ballast prisms -2.0 cm),
- ensuring that the ballast prism is properly profiled,
- increased surveillance of the operation section (control

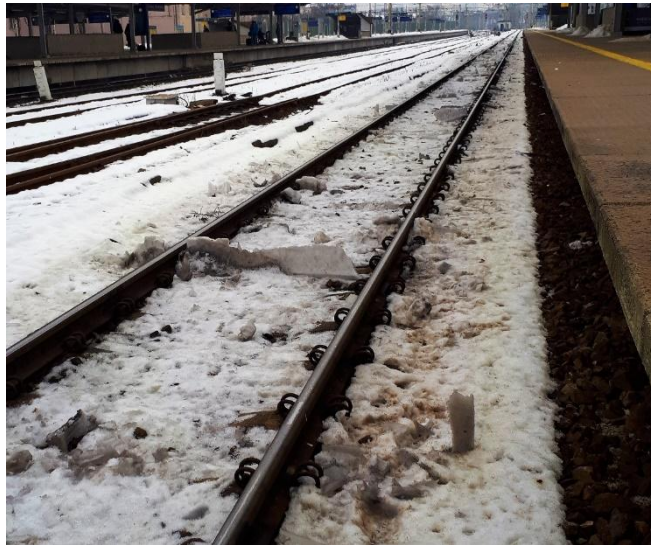
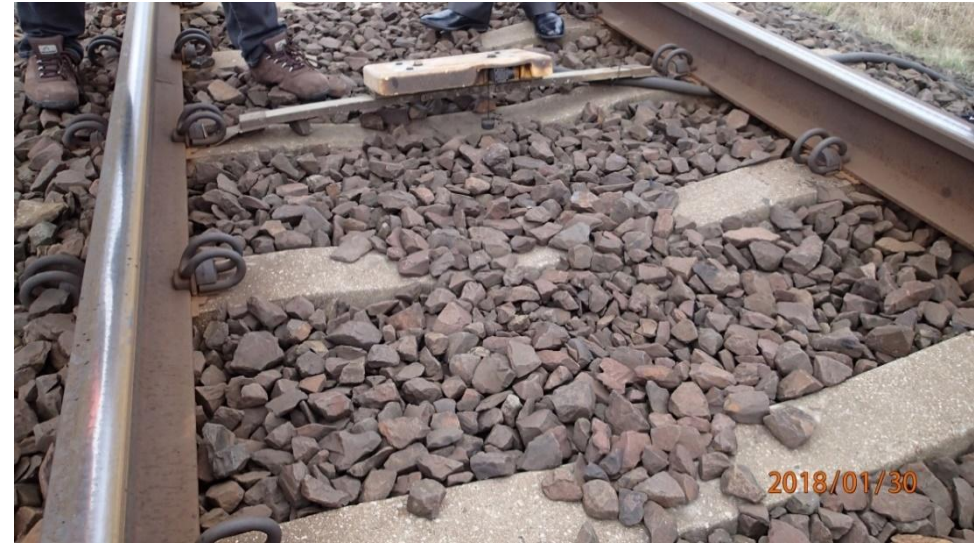
ST-T1-A8:

"The top surface of the ballast prism ("op") in the windows between the sleepers/switch sleepers shall be profiled to height of 0.02 m below the top edge of the sleeper center section..."

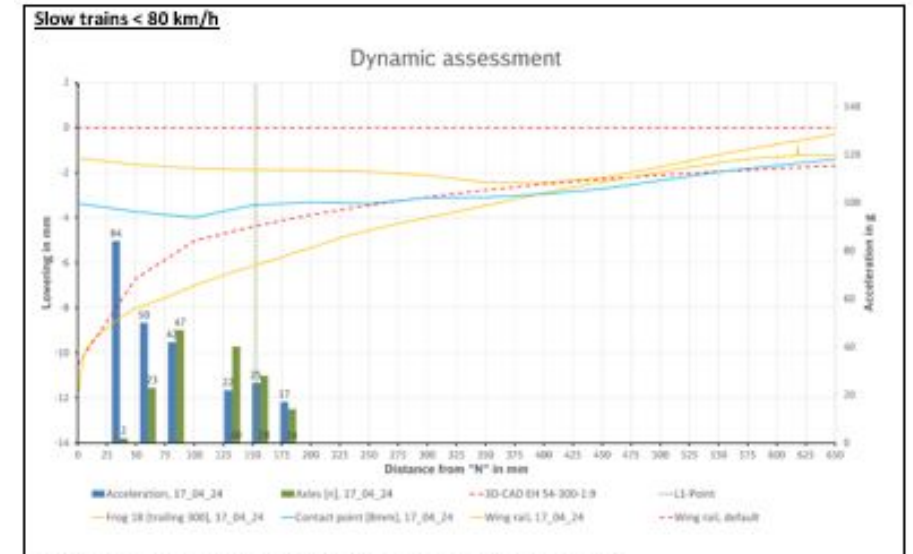
Figure 8: Frog ramp W18 with dynamic loads and wing rail progression, only slow trains

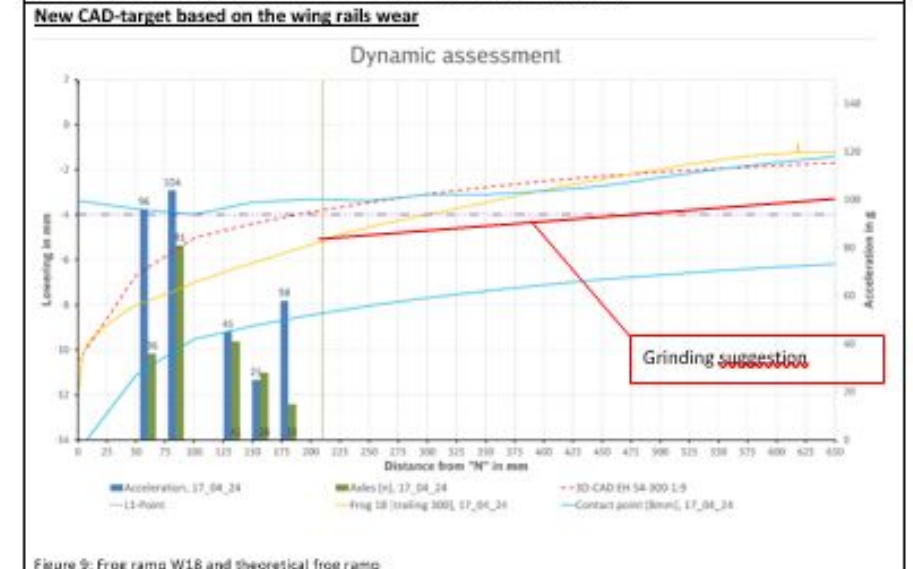
Figure 9: Frog ramp W18 and theoretical frog ramp

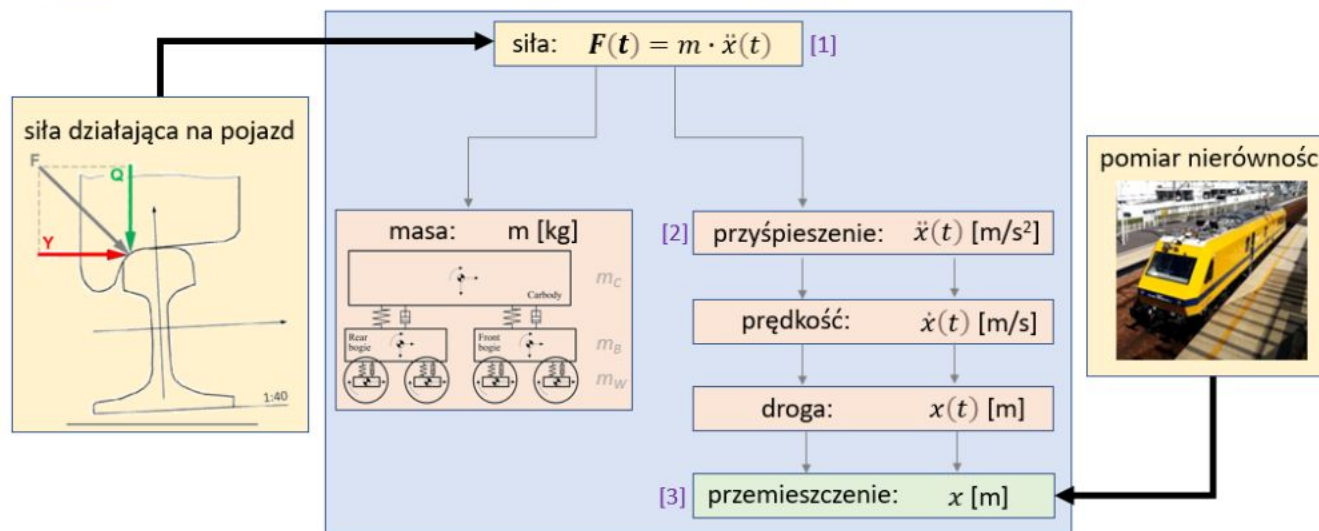
Rozważania w tym zakresie, jak zwykle to bywa, wypadaloby rozpocząć od początku, tj. od ustalenia właściwie w jaki sposób jakość geometryczna toru wpływa na zachowania pojazdu podczas jego jazdy po torze. Aby lepiej zrozumieć tą relację, musimy po pierwsze zdawać sobie sprawę, że „zjawiskiem” które tak naprawdę wpływa na zachowanie (spokojność jazdy) pojazdu po torze nie jest jedynie dobrze nam znana nierówność, lecz jest tak wypadkowa wielu czynników, które to zależą zarówno od charakterystyki pojazdu (prędkość, masa i jej rozłożenie, skuteczność zawieszenia/usprężynowanie, etc.) jak i cech toru (typ nawierzchni, stan powierzchni tocznej szyn, a przede wszystkim układ geometryczny oraz jego jakość). Parametrem, który chyba najlepiej uwzględni ogół ww. cech jest siła (wypadkowa) generowana na styku koło szyna $\{F(t)\}$. Siła jak wszyscy wiemy jest to iloczyn masy $\{m\}$ oraz przyspieszenia $\{a = \ddot{x}(t)\}$ – co opisuje równanie [1] pokazane na poniższym rysunku.

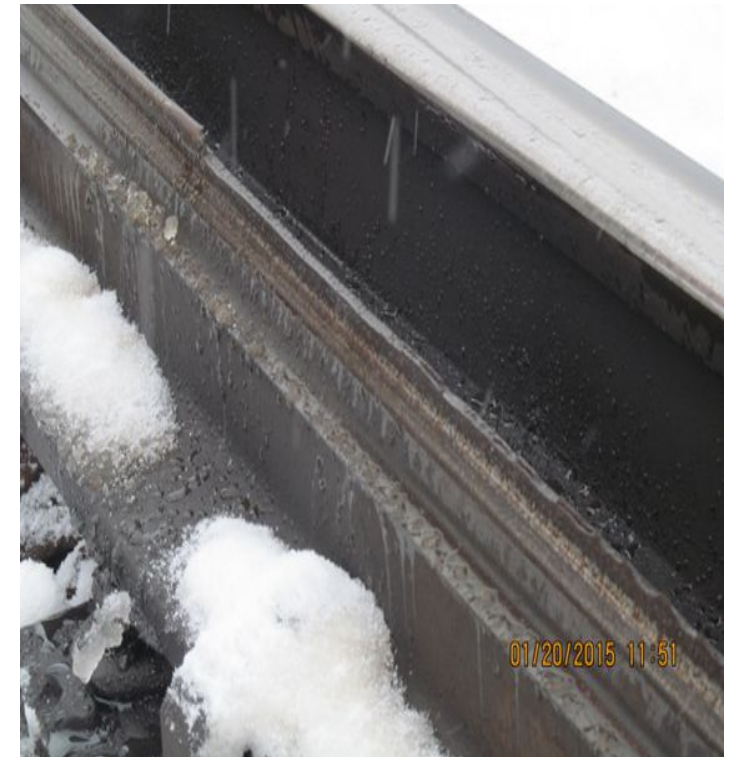
AOT project

HS line supervision, given the need to provide:

- worker safety,
 - process performance,
 - the high quality of the data obtained,
 - digital data format - essential for expanding predictive models,
- should be based on automated diagnostics minimising human involvement in the process.

A response to these needs is the Company's forthcoming Automated Track Inspections project, which aims to replace walking rounds with automated inspections, carried out using inspection vehicles equipped with a range of video inspection and measurement systems.

- automation of track inspections (project - AOT),
- qualitative and quantitative information from inspections received in a digital form,
- improving the quality of diagnostics.

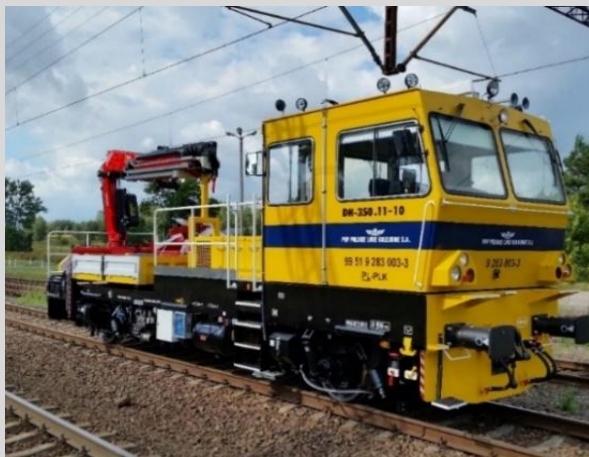
STATIONARY PART = OPERATOR STATIONS

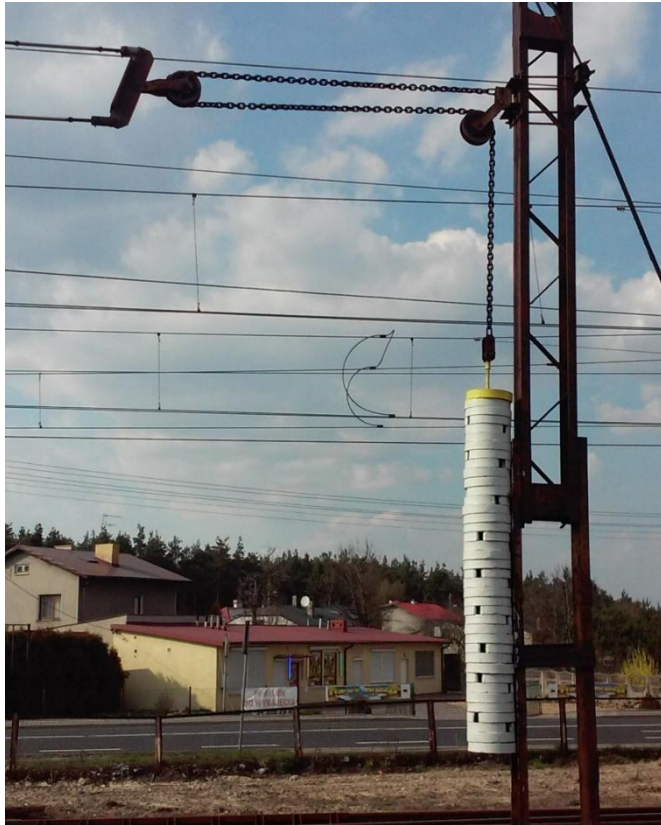
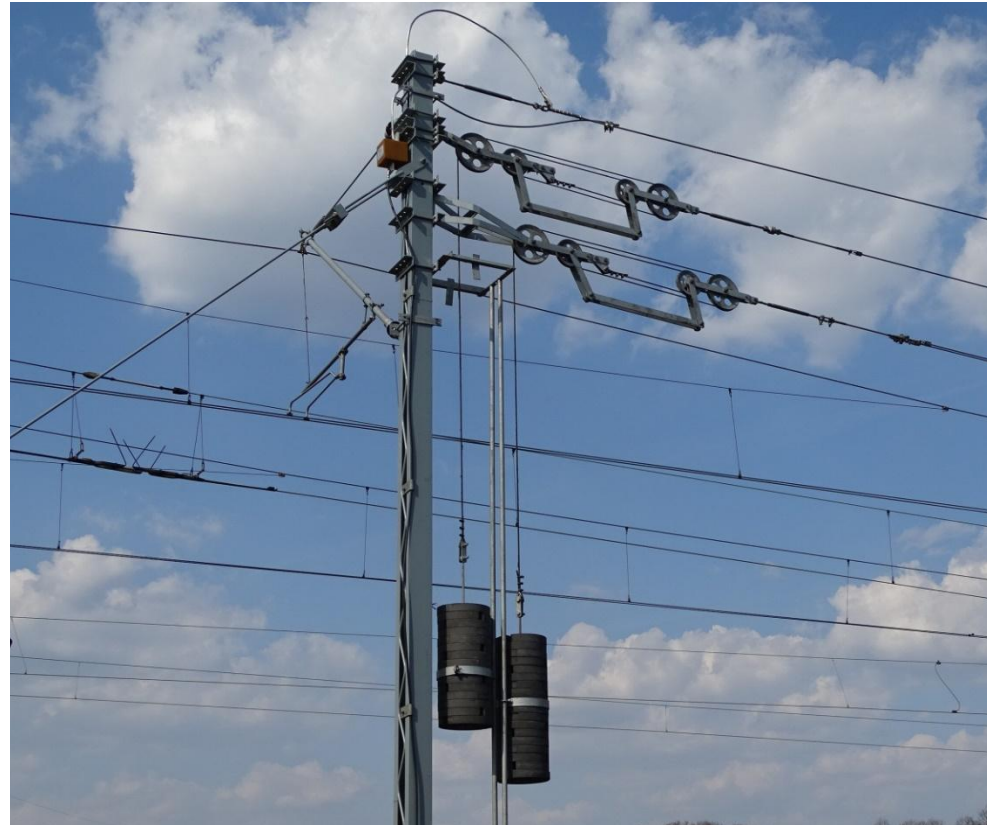
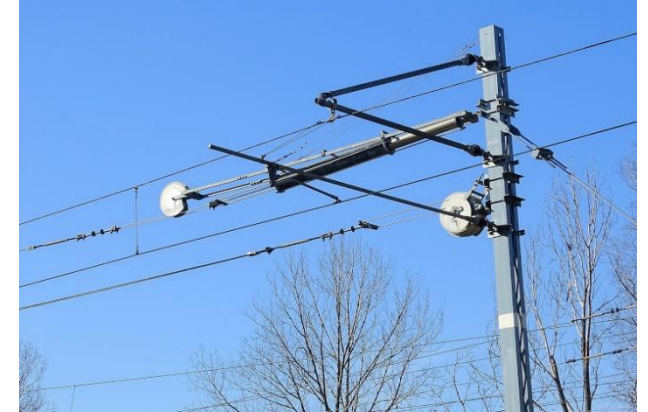
In order to ensure greater certainty of proper compensation of changes in the length of the network due to temperature changes, separate anchoring of the suspension cables and contact wires have been used, including the use of modern weightless tensioning devices.

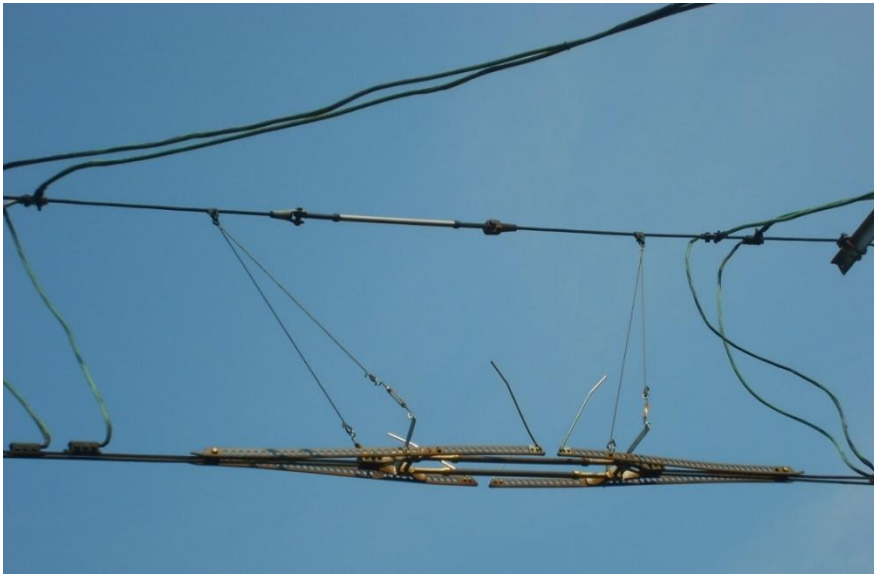
In order to improve the interaction at the current collector - OCL interface, a new generation of section insulators has been implemented to ensure uninterrupted passage of the contact strip through the electrically shared overhead contact line section.

- breaking strength - not less than 100 kN;
- torsional strength - not less than 50 Nm torsional force;
- no mechanical shocks between the contact pads of the current collectors and the section insulator elements.

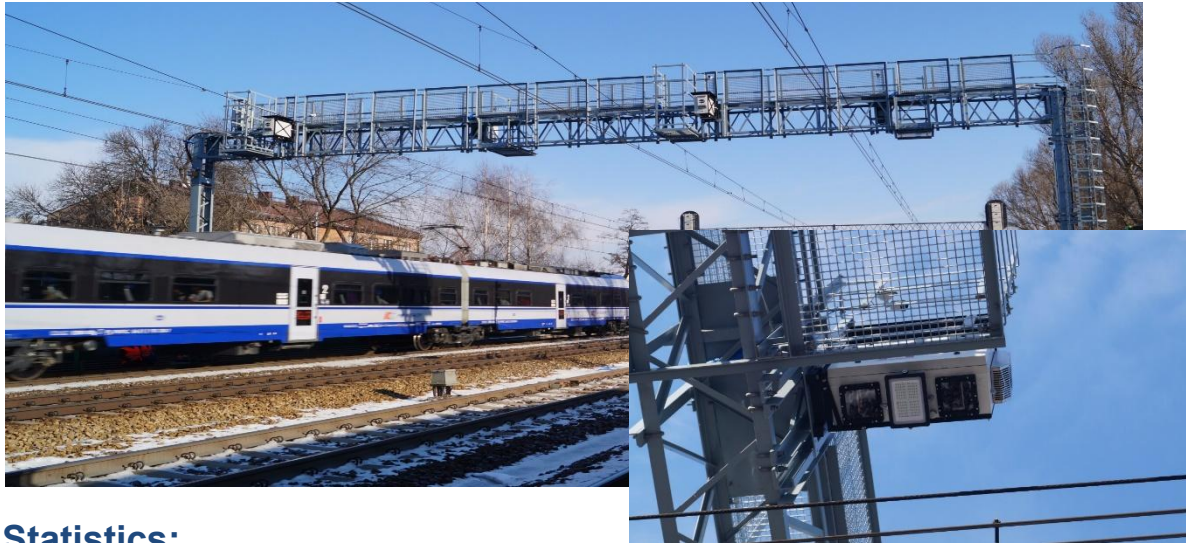
Statistics:

- 110,665 trains scanned;
- 6,965 (6.3%) trains with irregularities identified;
- 318 trains (4.6% of trains with an emergency condition) reported to operators on an urgent basis.

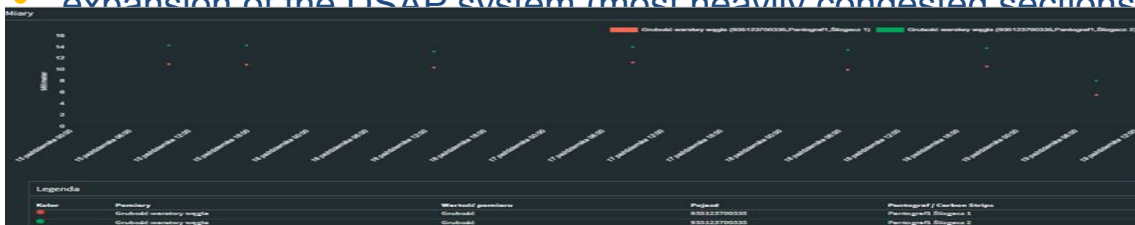
The DSAP system allows, among other things:

- measurement and verification of pantograph contact force,
- measurement of the wear and continuity of the carbon overlay (cracks, splits, chipping),
- measurement of wear asymmetry of carbon overlays,
- measurement of the position of the pantograph (in the x, y and z axes) relative to the vehicle,
- correctness of attachment of leading edges,

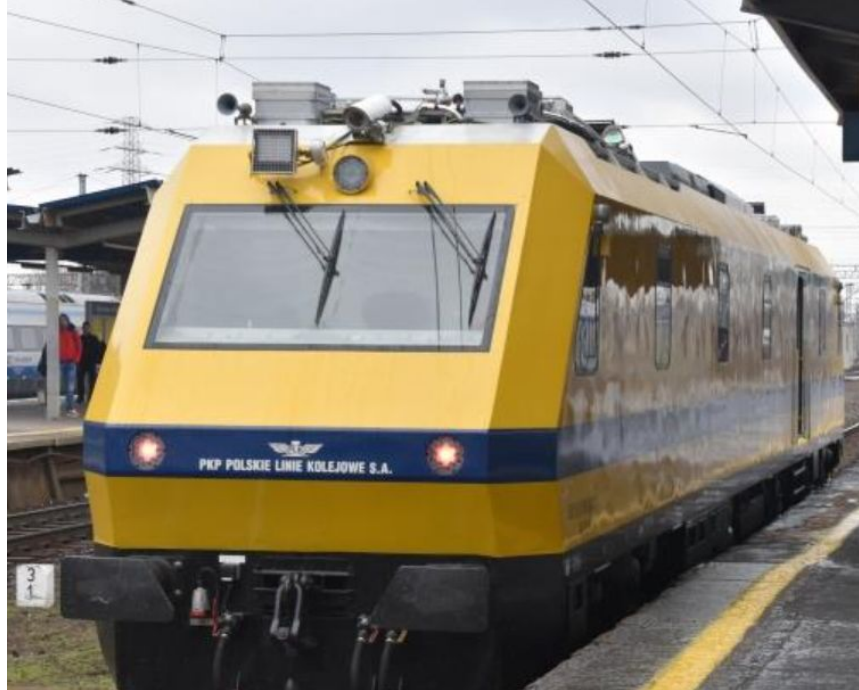
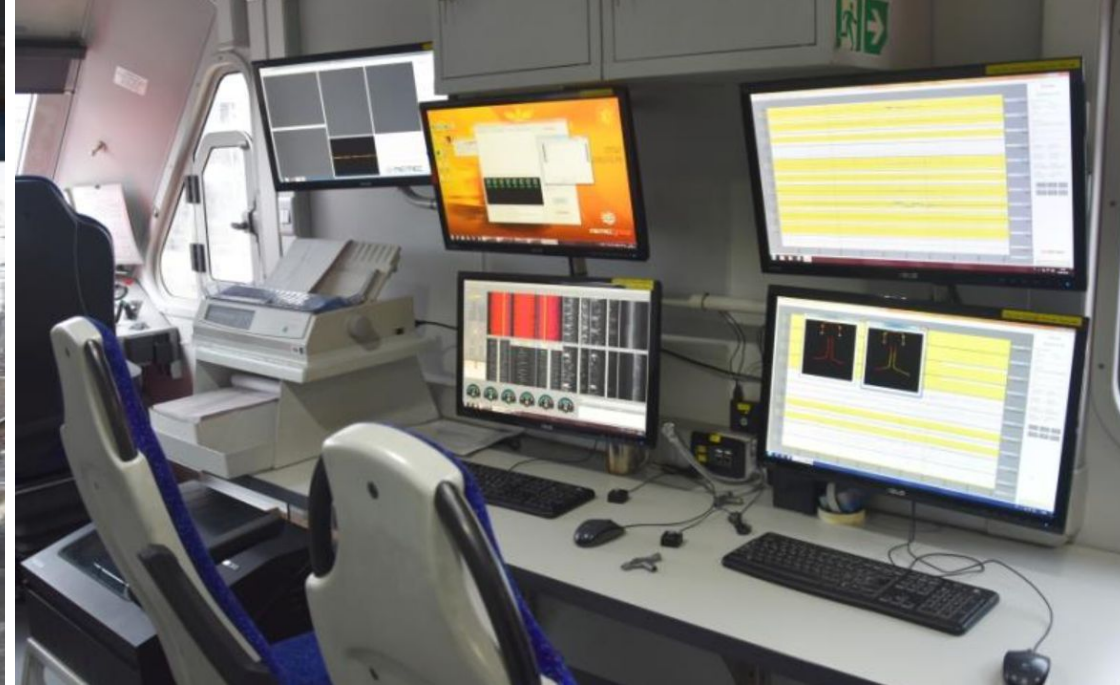
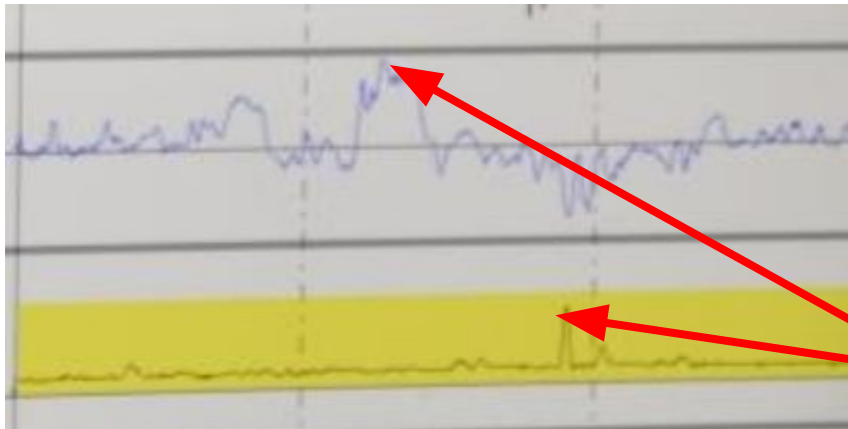
DP 560 Draisine

- offset
- djp suspension height
- wire thickness
- a detailed record of the diagnosed network section
- quick location
- network fault detection - inadequate regulation

Automatic recording exceedances of overhead line limit values.

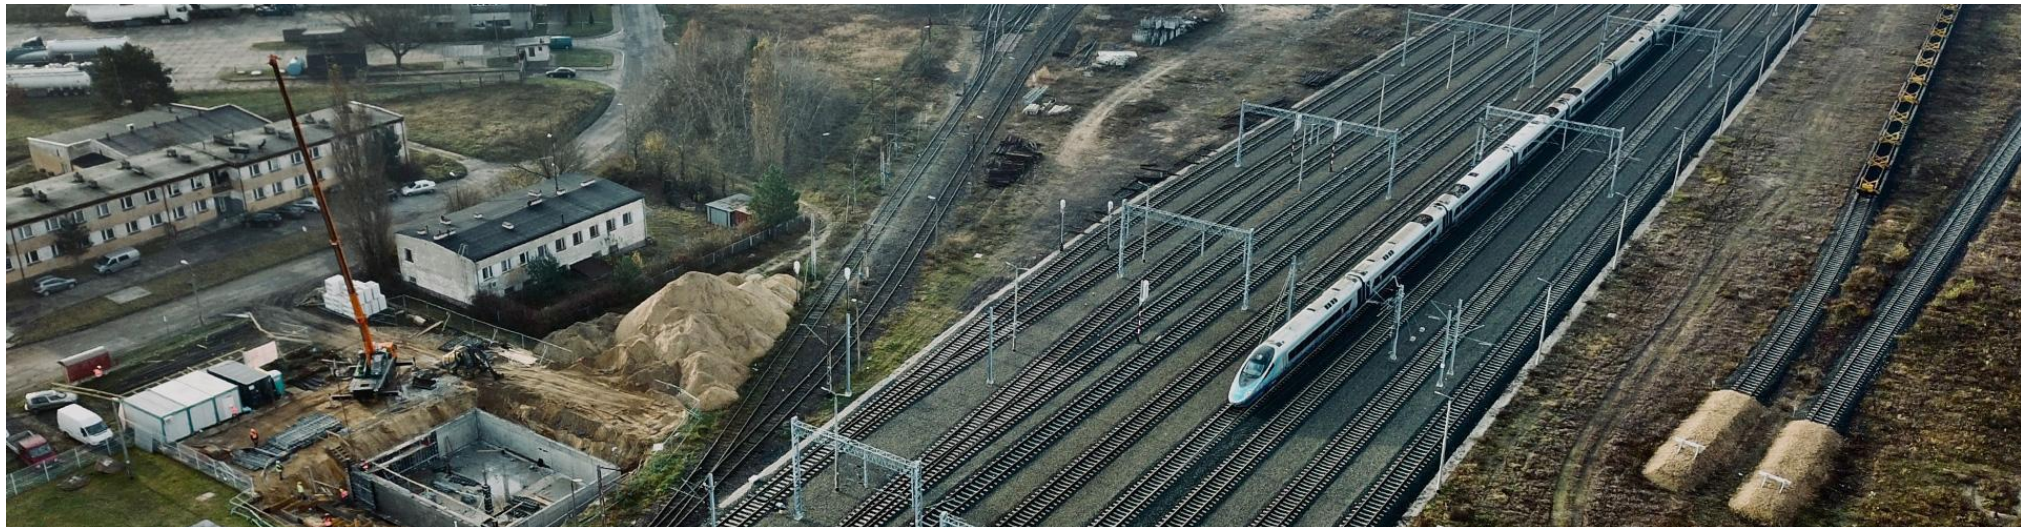
The project will centralize control - over 200 km of this line will be covered by one Local Control Center (LCC) together with Radio Control Center (RBC).

ETCS Level 1 on the Central Railroad Line has been in operation at speeds of up to 200 km/h since December 2014.

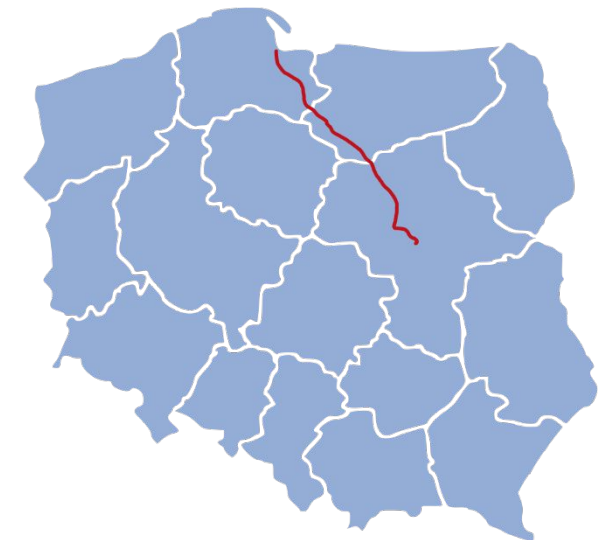
Railroad line no. 9 (E 65 Warsaw-Gdynia section)

- Operation of trains is being controlled at speeds of up to 200 km/h.
- ETCS Level 2 as a system ensuring continuous instructions of Movement Authority (MA) to the onboard equipment limits the influence of the adopted installation method of the base Class B layer system (length of block intervals, line interlocking rates) on the maximum speed at which trains run.
- The installation of the ETCS system required changes to the configuration of the crossing systems.

ETCS Level 2 on railroad line 9 has been in operation at speeds of up to 200 km/h since December 2020.

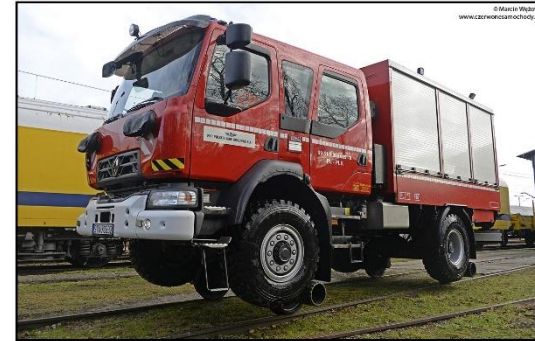
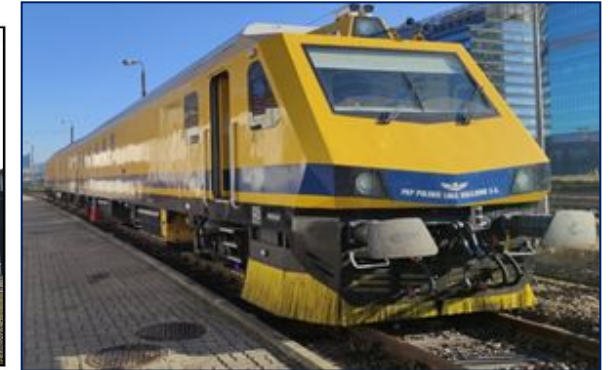
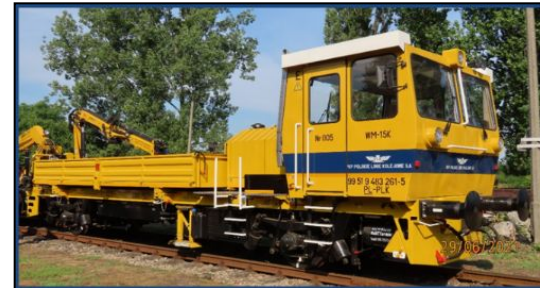
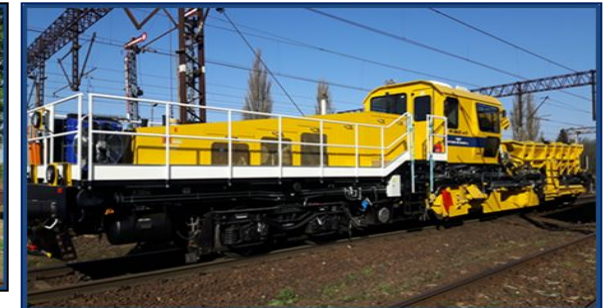
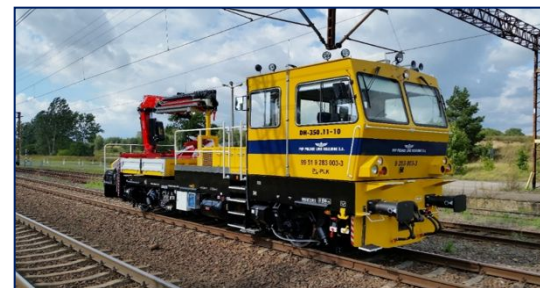
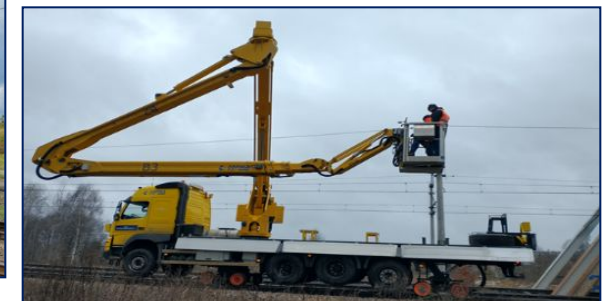
Rescue train:

- WM-15A/PRT00 technical rescue trains - **4 units.**
- UniRoller-S rail-road vehicles - **17 units.**
